Prediction of the future behavior of the existing dam, based on the results of auscultation measurements

Dajana Biorac

Enegroprojekt – Hidroinženjering Consulting Engineers Co, Belgrade, Republic of Serbia

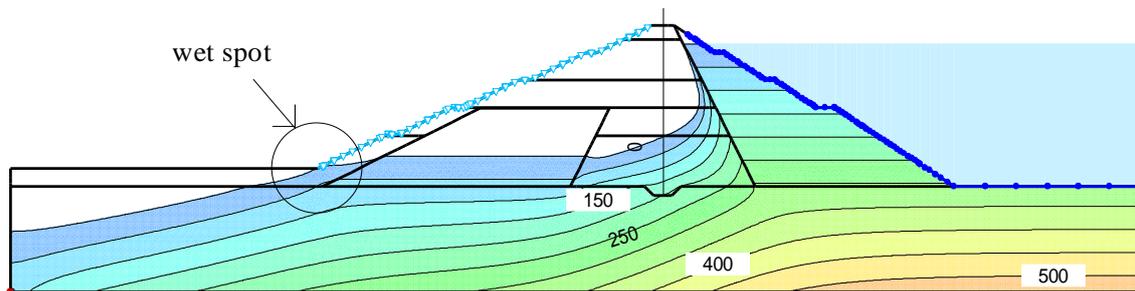
Figure 6. Piezometric line in the dam after 20 years of operation

After 20 (twenty) years of operation, the wet spot was noticed on the downstream slope of the dam during regular maintenance. The wet spot was located at the downstream toe of the dam in the central part, close to the axis of the dam. Extensive vegetation on the central part of the embankment dam indicated that the humid zone extends to the downstream slope of the dam above the wet spot. Emergency investigation revealed that excessive water on the downstream slope originates in the reservoir.

The numerical model shown in Figure 2, displays correspondence of the real field conditions for the period after 20 years of operation, with the application of an upstream hydraulic boundary condition corresponding to real changes in the accumulation levels (Figure 7).

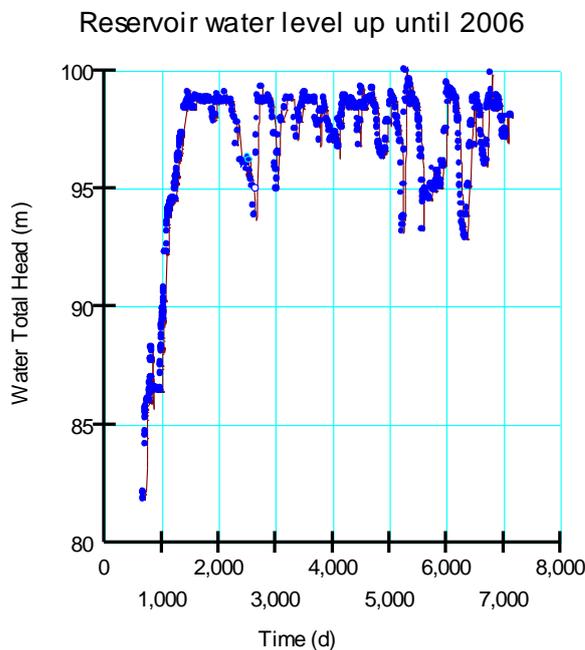
Figure 7. Reservoir water level up until occurrence of the wet spot

The change in the reservoir water level until the moment when the wet strain is noticed, is displayed in Figure 7.

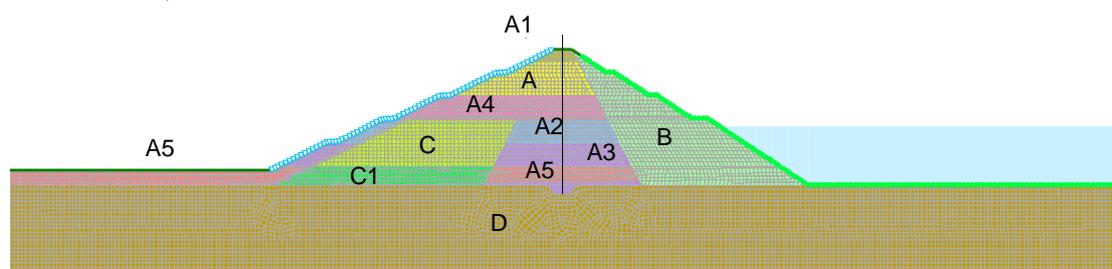
Figure 8. Construction model after remedial works

The value of the water permeability coefficient around the irrigation pipe was increased to $k = 10^{-8}$ m/s in the numerical analysis. This assumption was introduced due to the possible change of the clayey material due to the lowering of the water level in the accumulation, as well as due to the migration of the clayey material particles through the corroded irrigation pipe.

In addition, due to the closure of the irrigation pipe with concrete, as well as due to the grouting of the zone around the pipe - the value of the water permeability coefficient in material C (limestone and sandstone blocks) was reduced to $k = 10^{-8}$ m/s also in the zone around the pipe Figure 8. and Table 7).

In 2008 the reservoir level was lowered to a maximum of 93.6 m asl and the irrigation pipeline was filled with the concrete. The space between the irrigation pipeline and the concrete cover was grouted with the cement grout. After this emergency remediation, the reservoir operational level was additionally lowered to a 92.0 m asl.

It is foreseen to fill all the pipes within the dam body, with concrete during the rehabilitation works, after which the reservoir water level would return to 98.8 m asl.

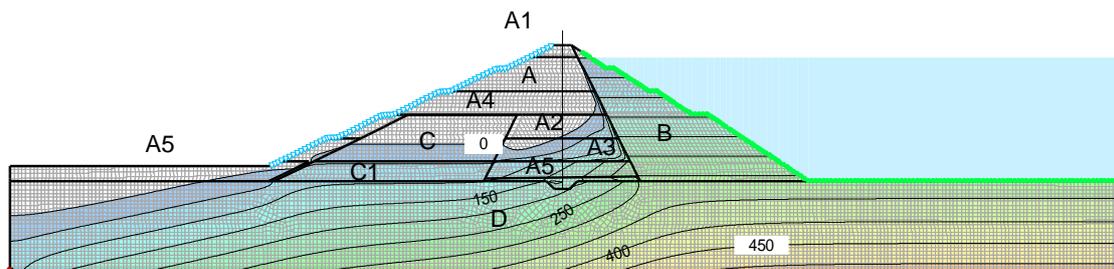
Figure 9. Piezometric line in the dam body after remedial works

Based on Figure 9, it can be seen that the piezometric line does not cross the downstream slope of the dam (water does not wet the downstream slope), which leads to the conclusion that remedial works had produced the desired effect. A downstream drainage curtain could be introduced as an additional measure. This would further lower the piezometric line at the side of the dam downstream slope.
