Behaviour of the embankment dam

Suggested theme for the 16th ICOLD BW

Basic information on the dam

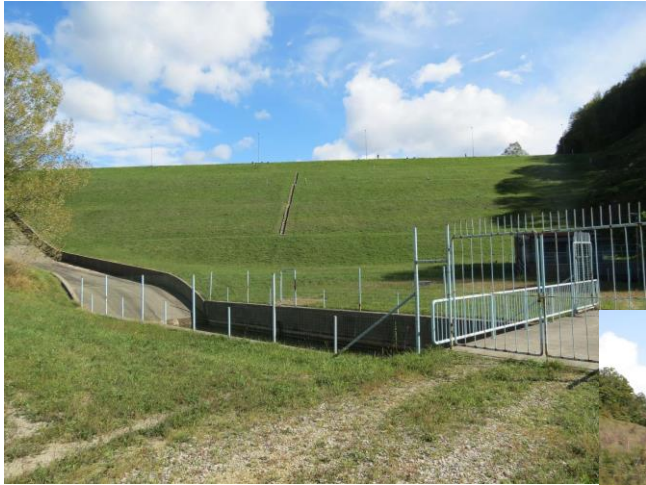
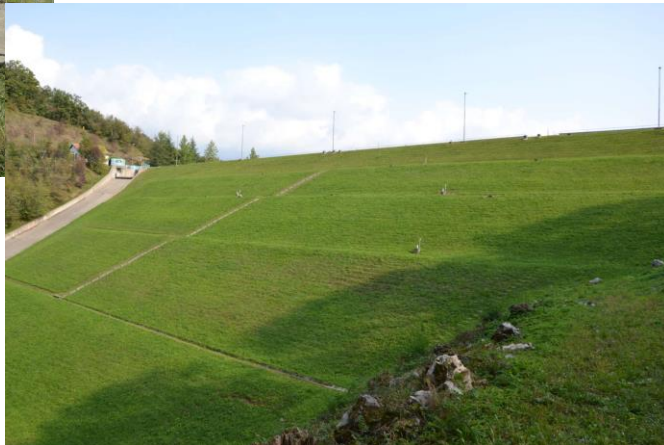
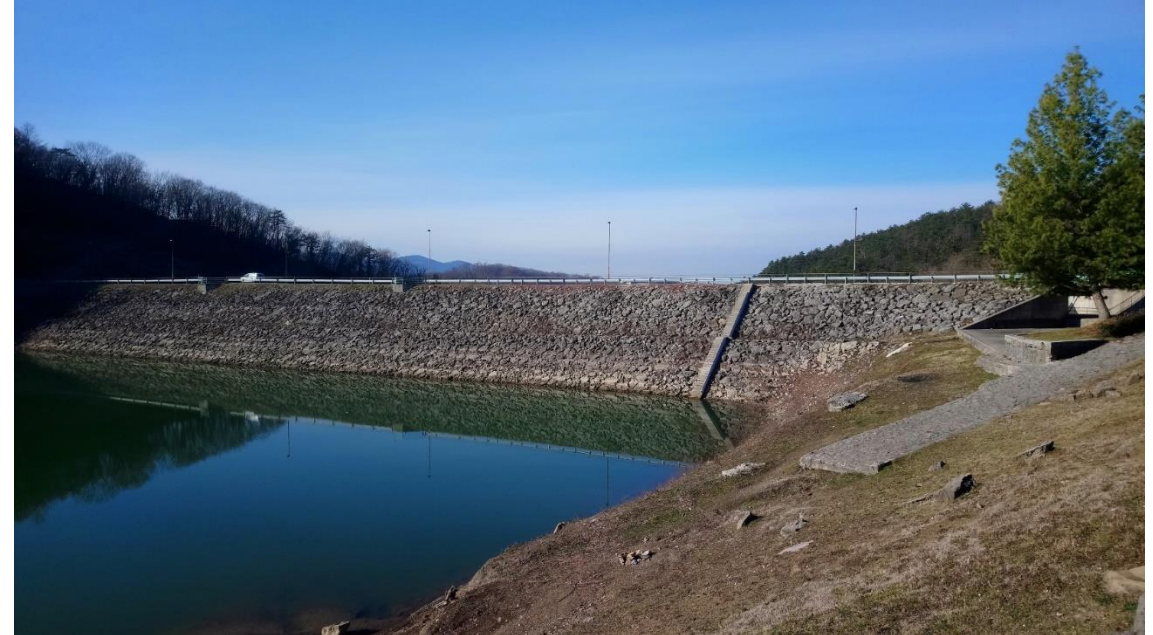
- Zoned embankment dam with a clay core.
- 35 m high, crest length 177 m.
